Stress Analysis in Longwall Entry Roof Under High Horizontal Stress

A Dissertation

Department of Mining Engineering
College of Engineering and Mineral Resources
West Virginia University

ABSTRACT

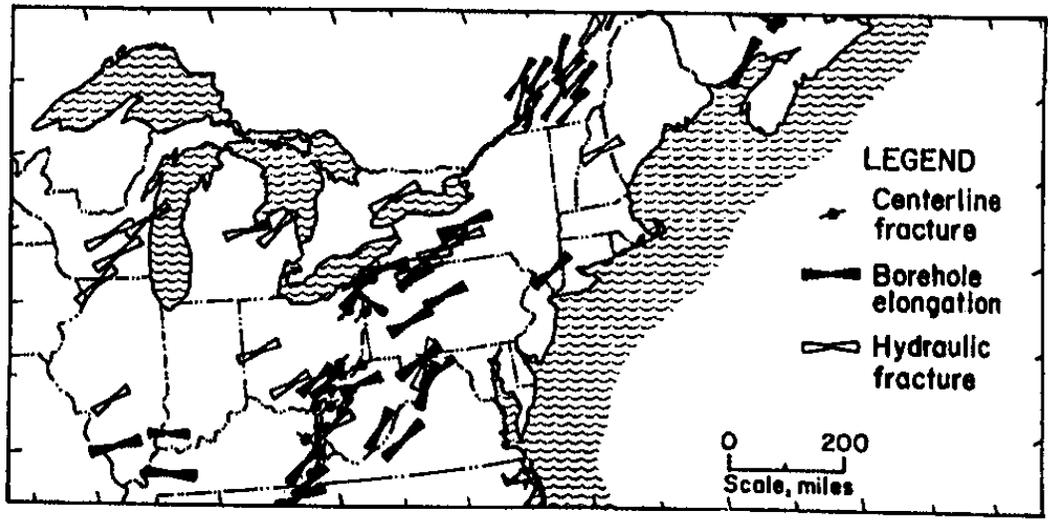
Fig. 2-1 Orientation of the Maximum Horizontal Stress in Deep Boreholes (after Plum and Cox, 1987)

In 1987, Plumb and Cox^[33] summarized the knowledge about the orientation of horizontal stress field in northeastern North America. Sources of their data included hydraulic fracturing stress measurements, borehole “breakouts” or elongations, and centerline fractures in the oriented cores. The measured depth ranged from 457 m to 1,200 m (1,500 to 4,000 ft). The data indicated that the maximum horizontal stresses were along E-NE direction, with some rotation towards E-W direction in the Illinois basin, as shown in Fig. 2-1. Stress measurements conducted in 25 underground coal mines throughout the eastern US confirmed the presence of the E-NE stress field^[27]. Figure 2-2 shows that 67% of the measurements from mines in the Appalachian and Warrior coal basins found the orientation of maximum horizontal stress between N50E and N80E. In the Illinois basin, 75% of the measurements indicated that the stress field is rotated towards E-W direction by about 15⁰. The stress provinces of the U.S. is shown in Fig. 2-3^[42].

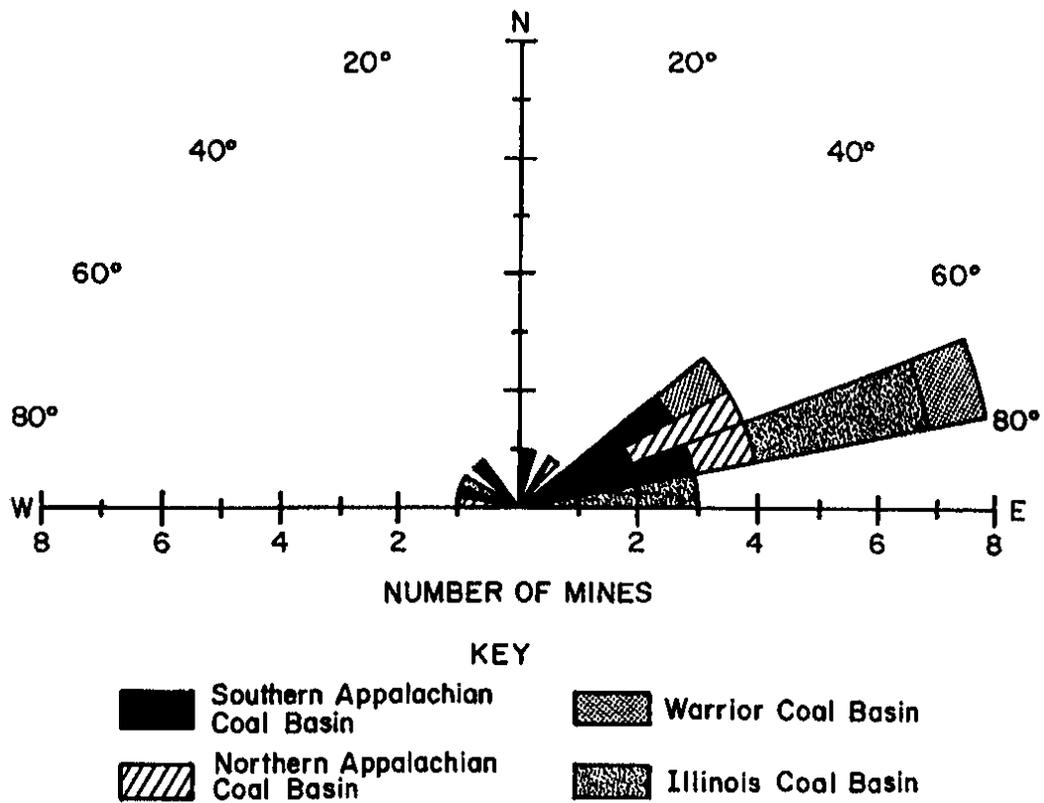
Fig. 2-2 Orientation of the Max. Horizontal Stress Measured In Eastern US Coal Mines (after Mark, 1991)

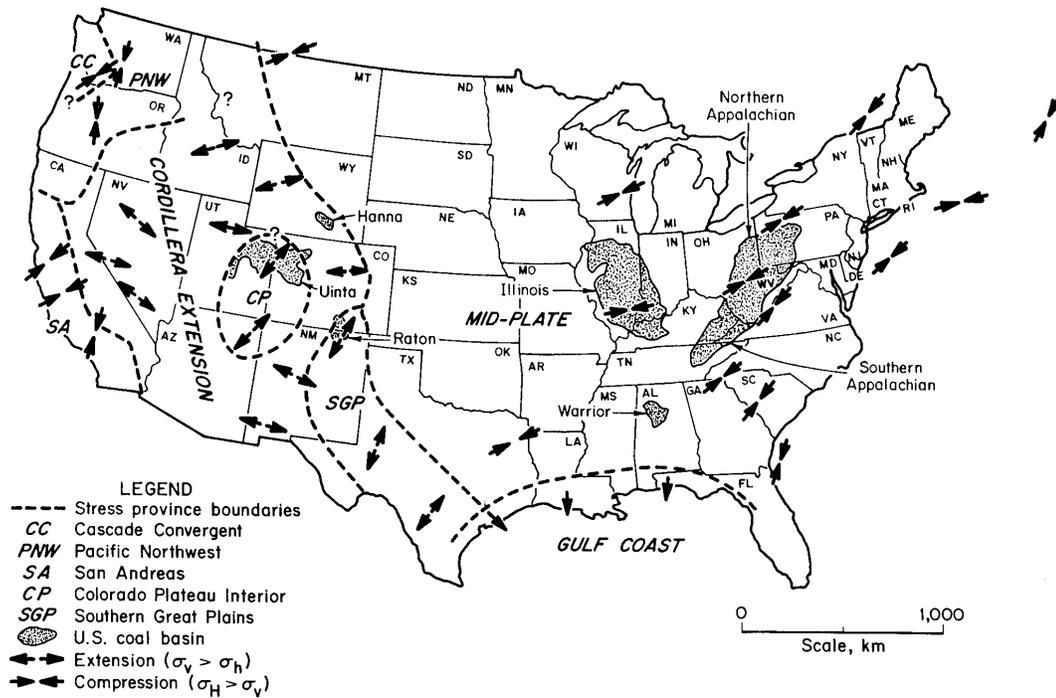
Fig. 2-3 Stress Provinces of the Continental United States (after Zoback and Zoback, 1989)

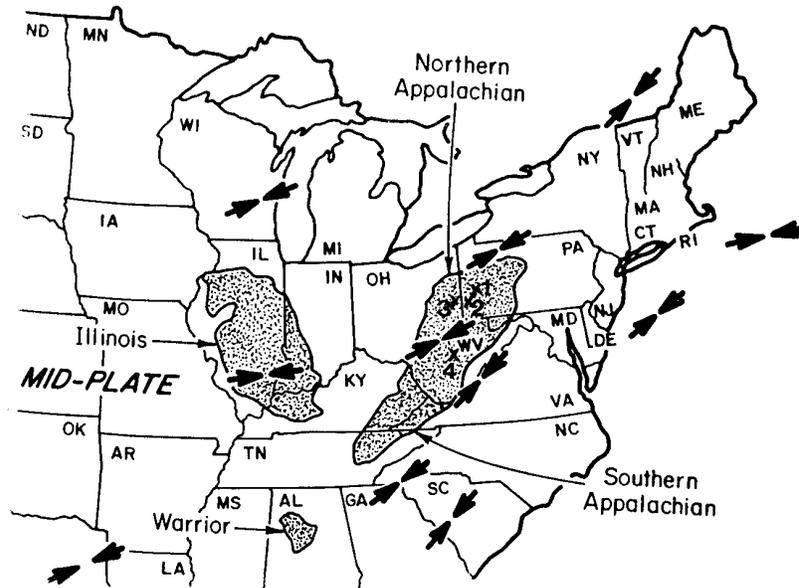
Fig. 2-4 Regional Horizontal Stress Fields and Locations of Mines (after Su and Hasenpus, 1995)

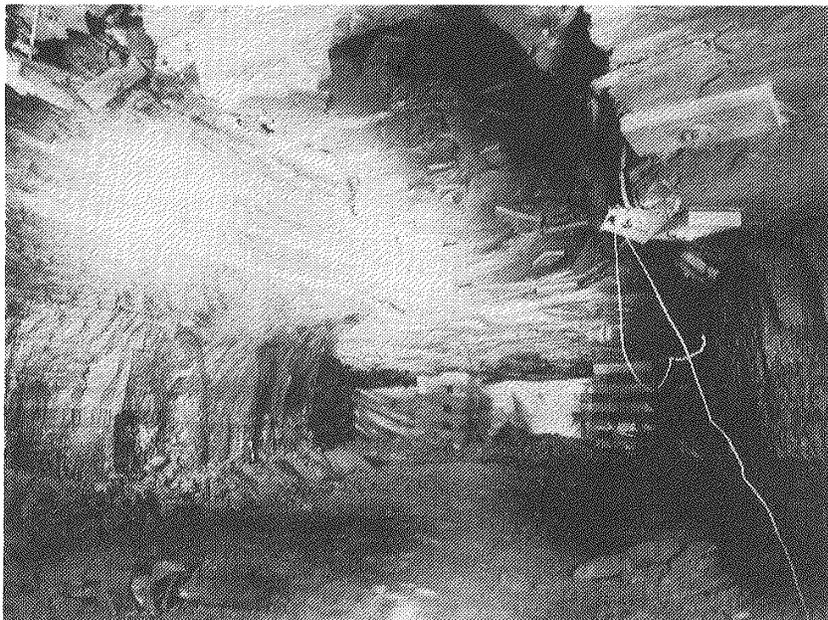
**Fig. 2-6 Remaining Cavity Following Overall Roof Collapse
(Courtesy Bureau of Mines, Pittsburgh Research Center)**

both upper corners of an entry and is difficult to control by conventional roof support, as shown in Figs. 2-5 and 2-6.

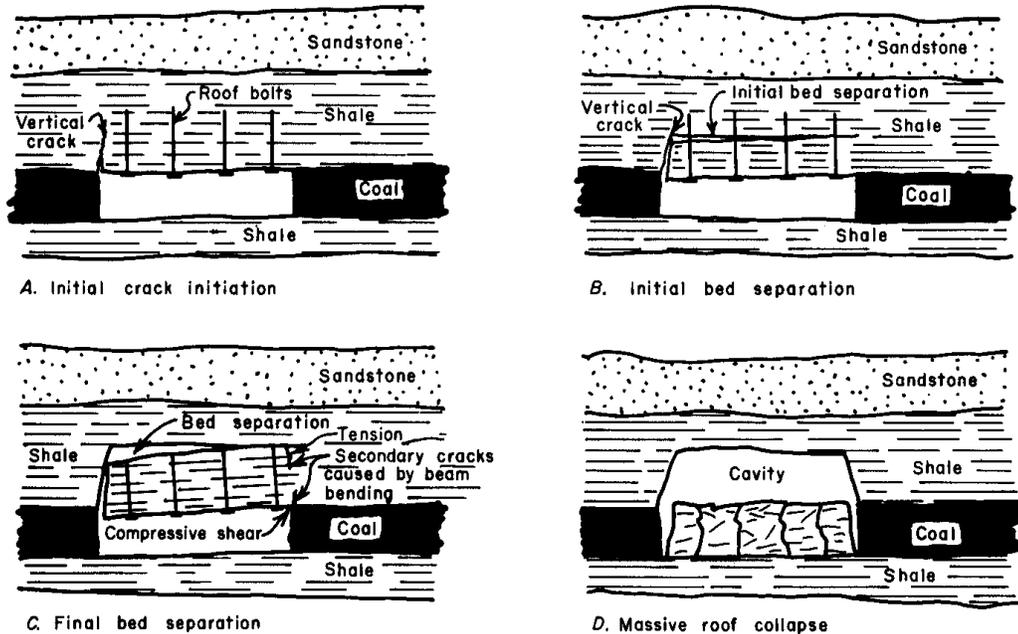
Fig. 2-7 Progressive Sequence of Events Leading to Overall Roof Collapse Resulting from Cutter Roof Failure (after Kripakov, 1982)

It has been suggested that cutter roof is caused by the shear stress at the entry corners being larger than the shear strength. This high shear stress at the corners results from either a large overburden weight and/or high horizontal stress at the rib. If separations between strata

or a weak bedding plane exist, shear failures that originate at the corners and propagate upward may stop at the first separation of a weak bedding plane. Traditionally, the kind of problem encountered with supporting roof conditions of this nature is that, regardless of the length of roof bolt installed, with time, a massive roof collapse still results, usually to a height equal to the bolt length as shown in Fig. 2-7^[24].

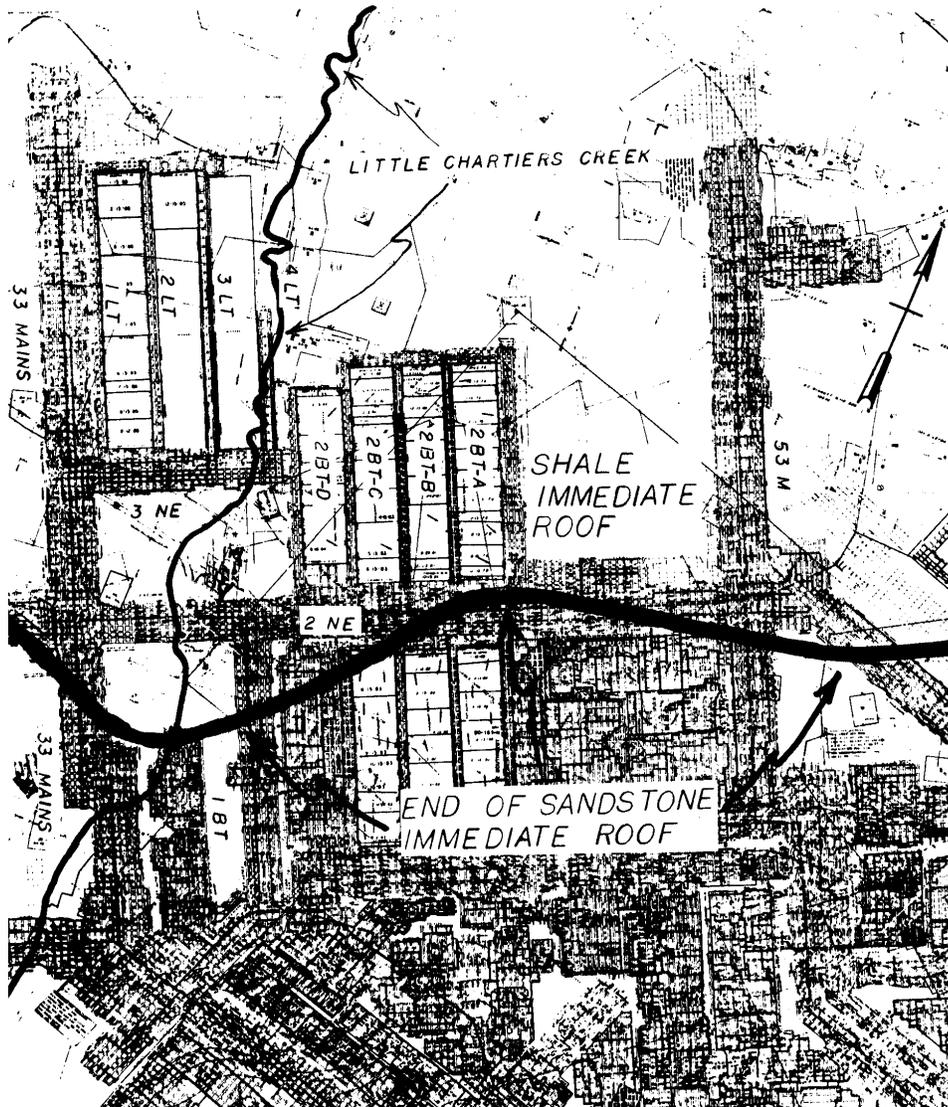
Fig. 2-8 Layout of Study Site in Beth Energy Mines (after Mucho, 1986)

Figure 2-8 shows the layout of panels. In the study site, the immediate roof was comprised of thinly laminated shale and coals. The entry width was 16 to 18 ft and the overburden generally varied between 450 and 700 ft. Two types of roof control problems occurred at BethEnergy's Eighty Four Mine in Southwestern Pennsylvania, namely poor roof conditions encountered while advancing submain entries and longwall panel entries and

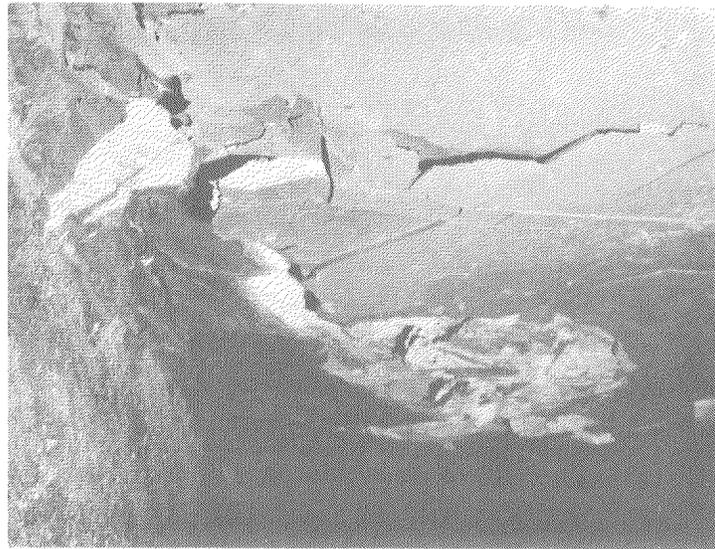
Fig. 2-9 Cutter Roof Develops a Short Distance behind the Face and Follows Entry Advance (after Krupa and Khair, 1991)

Roof control problems during entry development occurred when the faces of the 33 mains entries completely caved. Severe “cutter roof” problems were encountered in the 2 Butt-D development section, the 3 NE submains, and the 2 Left, 3 Left and 4 Left longwall development sections. Figures 2-9 and 2-10 show the cutter roof failures in the entries.

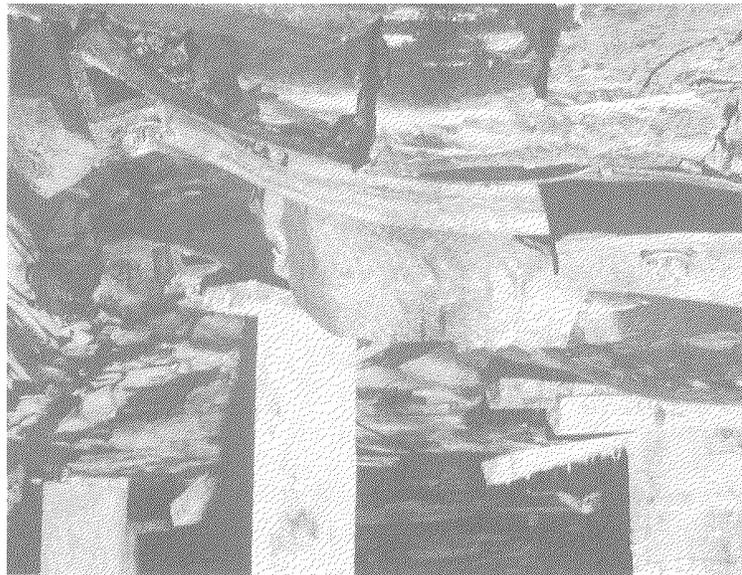
Fig. 2-10 Failed Roof Bolt at the Cutter Zone (after Krupa and Khair, 1991)

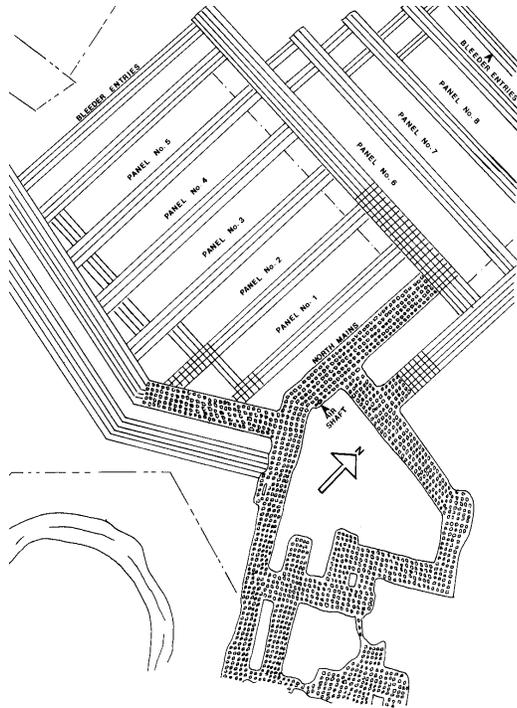
Fig. 2-11 Longwall Projections (after Su and Pang, 1987)

Figure 2-11 shows the longwall projection of a coal mine in West Virginia (Su and Peng, 1987). The immediate roof over most parts of the mine consisted of a layer of gray shale (3~4 ft), overlain by a thick layer of sandstone. Over the portion of the mine where cutter roof failures were observed in longwall development entries, however, the immediate roof was a layer of black shale (3~4 ft) overlain by a layer of gray shale (3~4 ft). Overburden depth was around 800 ft.

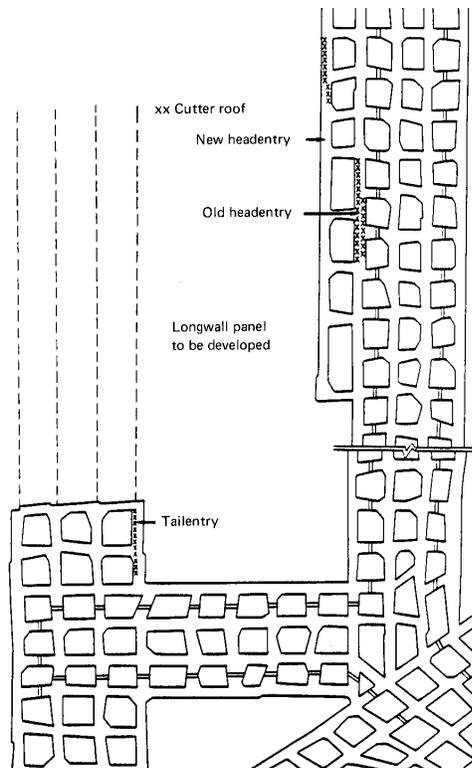
Fig. 2-12 Cuter Roof in Longwall Development Entries (after Su and Peng, 1987)

Cutter roofs usually occurred in the first and second entries one or two breaks behind the faces, as shown in Fig. 2-12. Once the cutter was initiated, cribs were installed to support the roof. Cutter roofs were also spotted along the entries developed from the bleeders near the northern end of the property.

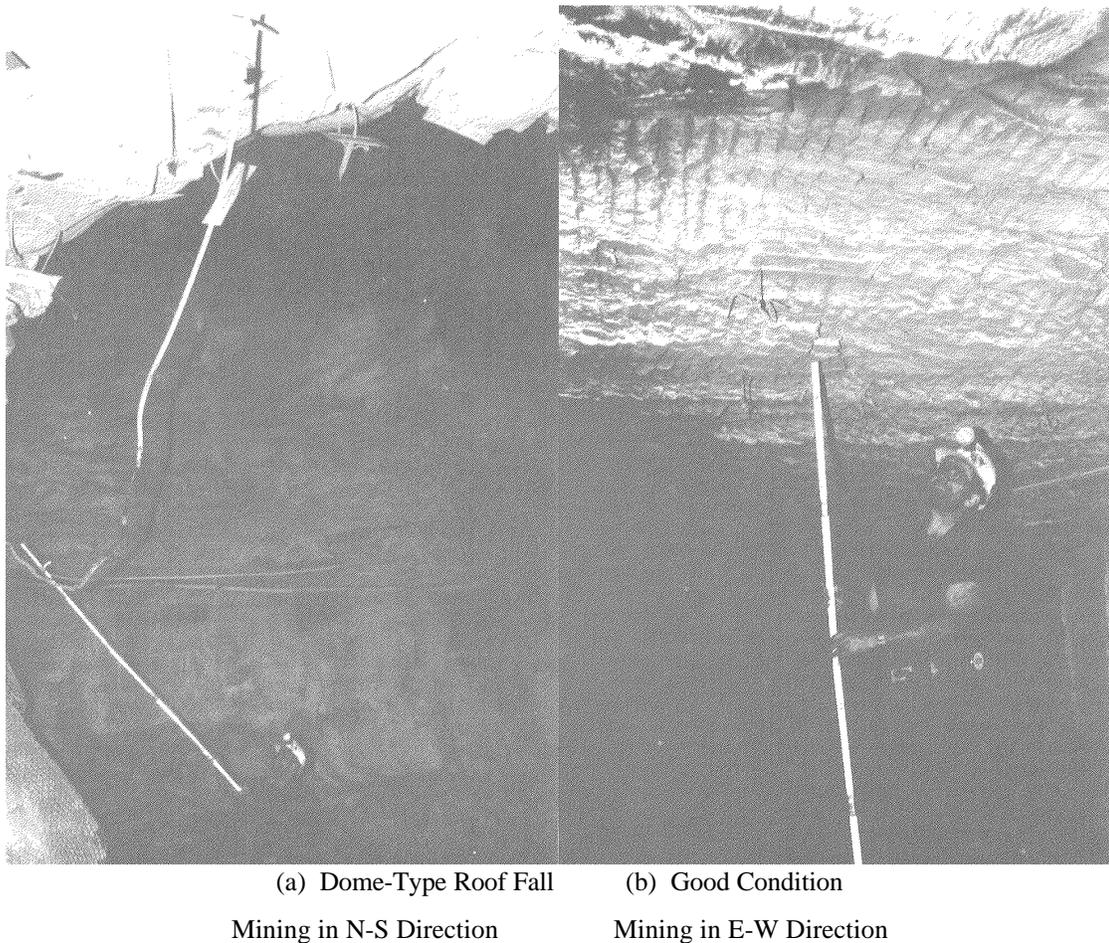
Fig. 2-13 Roof Condition in Different Mining Directions (after Hanna, et al., 1986)

Figures 2-13 shows the different situations of entry roofs in the Inland Steel No.2 Mine when some entries were located along the N-S direction and other were along the E-W direction^[15]. They indicate that entries along the E-W direction (parallel to the maximum horizontal stress) were in good condition while those along the N-S direction were in worse condition.

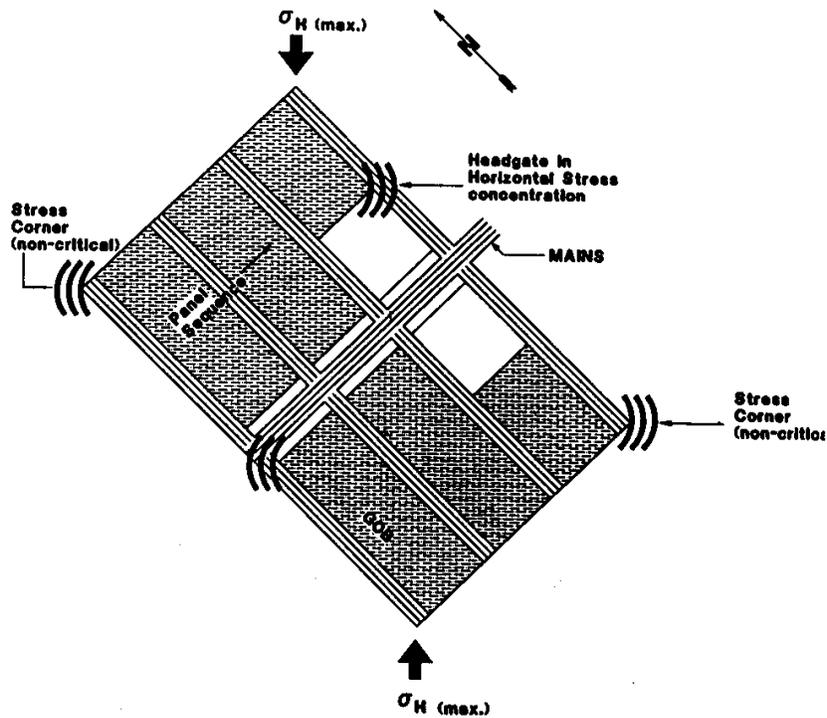
Fig. 2-14 Horizontal Stress Concentration Caused by Retreat Mining (after Mucho and Mark, 1994)

In a multiple-panel system, since the horizontal stress cannot pass through a gob area, zones of stress relief and stress concentration are created, as shown in Fig. 2-14^[28]. Mark et

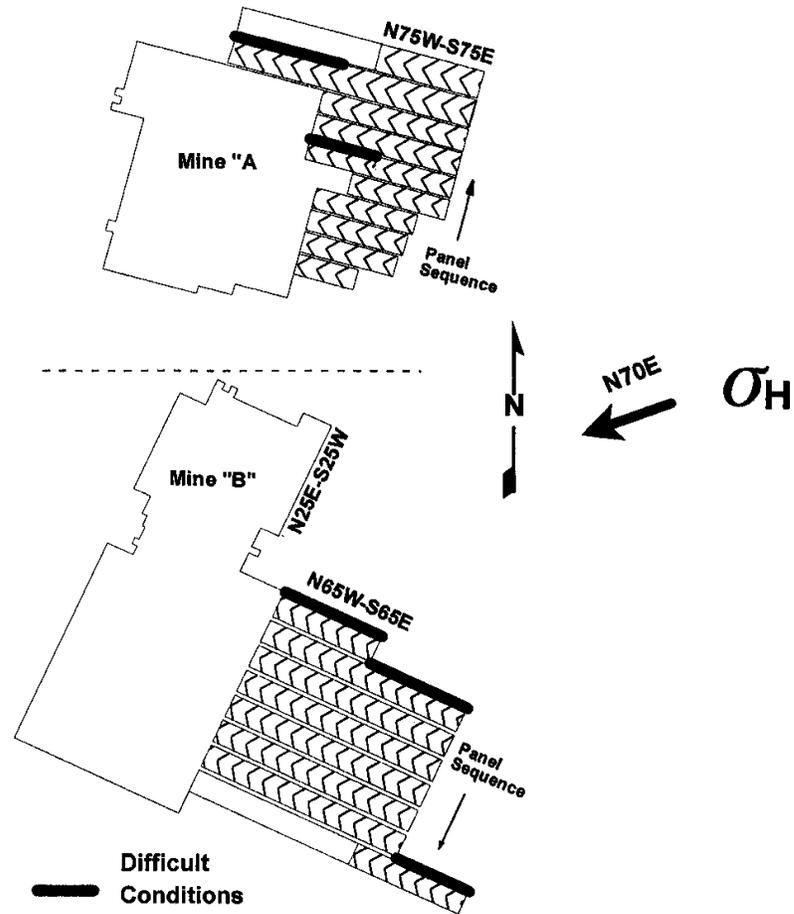
Fig. 2-15 The Study Site in Mines A and B (after Mark, et al., 1998)

al^[28] investigated the headgate problems in several coal mines. Figure 2-15 shows the problems in mines A and B. Mines A and B are adjacent Pittsburgh seam longwall mines located in southwestern Pennsylvania. The average overburden is about 700 ft. The immediate roof is composed of typical Pittsburgh seam sequence of coals and laminated shales and the maximum horizontal stress direction is between N70⁰E and E-W. At mine A, the primary longwall ground control problems have been on the headgate. This is due to panel sequencing. At mine B, the current panel sequence is opposite that of mine A, and the headgate experiences stress-relief conditions during longwall retreat. However, the first panel encountered stress concentrations and several major headgate roof falls.

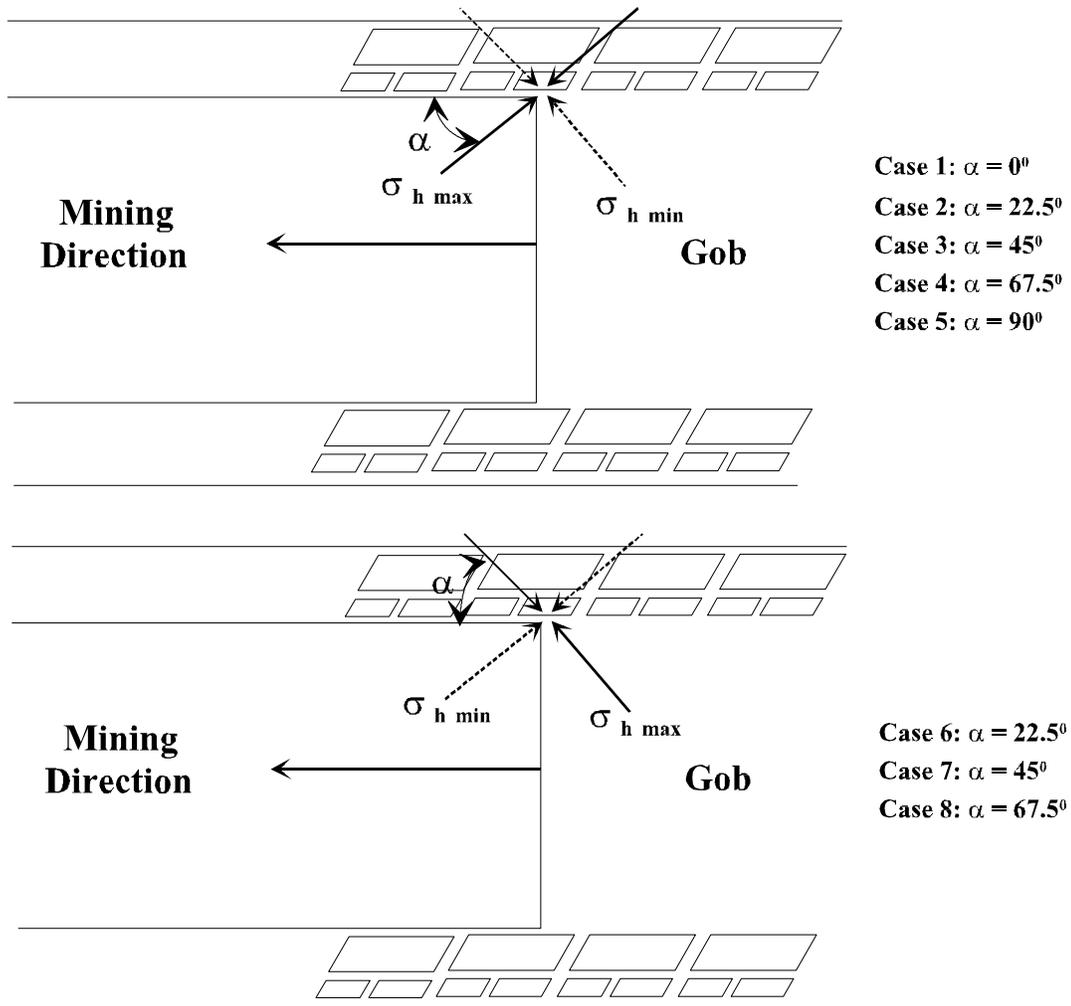
Fig. 2-16 Relative Orientation of Max. Horizontal Stress and Direction of Mining (after Su and Hasenfus, 1995)

In order to research the influence of the angle between the maximum horizontal stress and mining direction on the entry stability in longwall panels, the numerical methods, such as the finite element method and the boundary element method, have been widely used^[2, 27, 41]. Su and Hasenfus^[39] analyzed the stress concentrations in the headgate, using three-dimensional finite element modeling, as shown in Fig. 2-16 and Table 2-3. It was found that the headgate was in worse condition when the angle was $45^{\circ} \sim 90^{\circ}$. Wang and Peng^[41] studied the stress redistributions in the roof of headgate/tailgate entries. In their study, the Von-Mises failure criterion was used. The models used and the results are shown in Fig. 2-17 and Table 2-4, which indicate that the headgate/tailgate entries were in worse conditions when the angle ranged from $67.5^{\circ} \sim 90^{\circ}$ and that the tailgate was worse than the headgate.

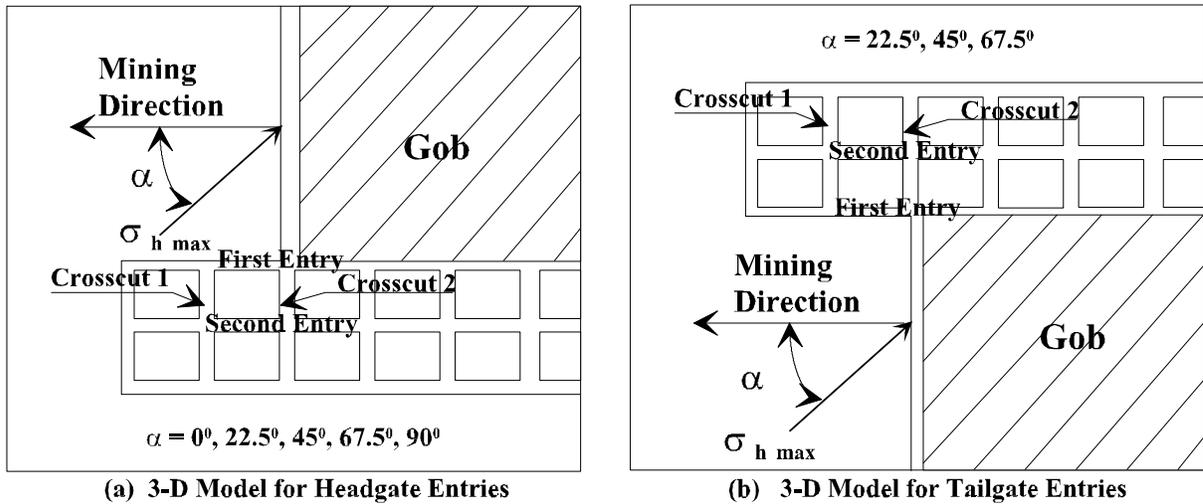
Fig. 2-17 Finite Element Models Used by Peng and Wang

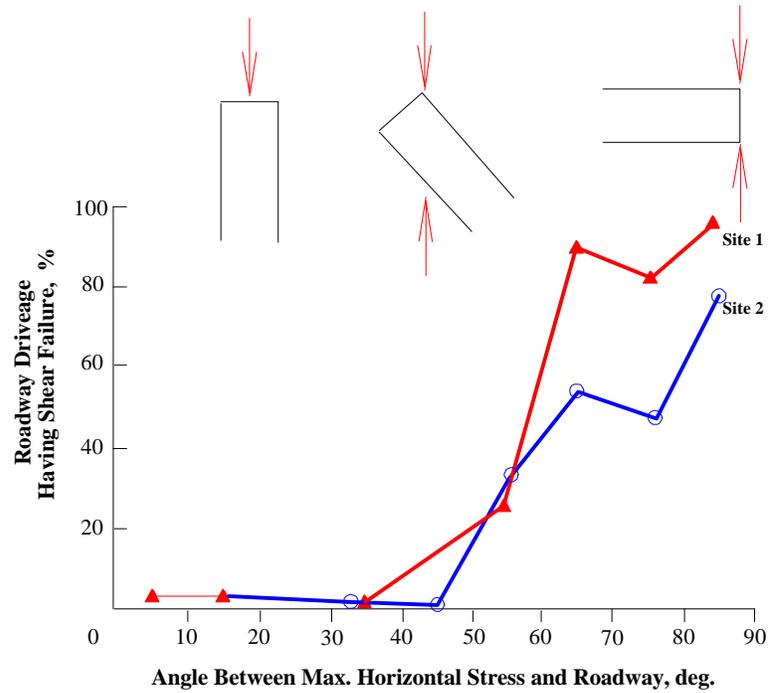
Fig. 2-18 Roof Failure vs. Stress Angle (after W.J. Gale, 1991)

In addition, the effects of the horizontal stress on the entry stability have been widely studied in Australia. Fig. 2-18 shows a practical example of the percentage of entries suffering shear fracture of the roof strata plotted as a function of the angle at which the entry is driven to the maximum horizontal stress (Gale, 1991)^[13]. In this example, the vertical stress is about 14 MPa, the maximum horizontal stress is 25 MPa, and the minimum horizontal stress is 14 MPa. It indicates that entries driven parallel to the maximum horizontal stress suffer little or no deformation while those driven at angles about 45° suffer an increasingly significant level of deformation. In addition, the location of roof failure is also influenced by

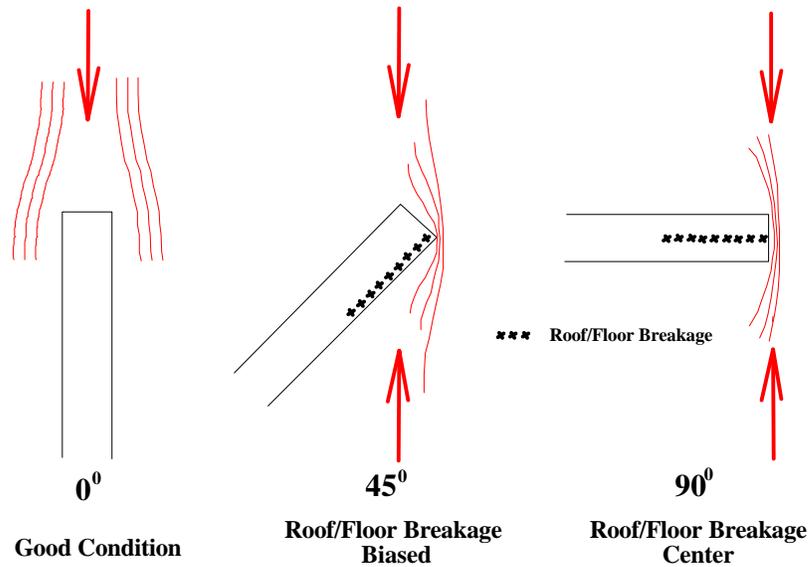
Fig. 2-19 Effect of Horizontal Stress Direction (after W.J. Gale, 1991)

the angle, as shown in Fig. 2-19. When the angle is from 40° to 75° , the roof failure may occur in one rib side. As the angle increases to 80° to 90° , the area of roof deformation locates toward the entry center (Gale, 1991)^[13].
